**Flood Control Project Maintenance  
Levee Inspections**

**Fall 2014 Levee Maintenance Deficiency Summary Report**

***San Joaquin River Basin***

**Reclamation District No. 2094 Wathal**

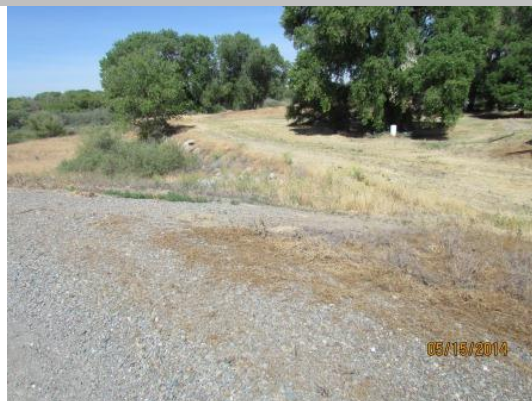
Photo 1 of 1 : FA\_2014\_RD2094\_320\_4\_20141001\_00001.jpg

LM Start	0.10	Rating **	M	Issue No.	4
LM End	0.10	Issue Type +	En	Location *	WS
Category	Earthen Levee			GPS Latitude/Longitude	
				Start	End
Item	Encroachments			37.771685 °	37.771685 °
				-121.300239 °	-121.300239 °
DWR ID	DWR_RD2094_01_s_2012_4				
Action/Comments					
Ramp Inspector Comments: An access ramp has been built on the water side and extends into the channel. This could potentially alter the channel capacity. This item was also noted in the USACE comments.

Tire marks shown onto the ramp from levee. Raised area extends to the trees in the background in the center of the photo.

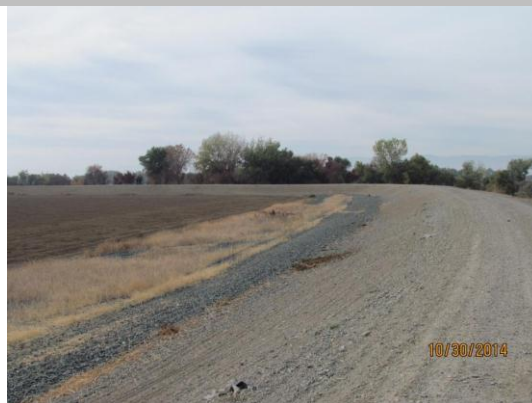
Photo 1 of 1 : FA\_2014\_RD2094\_320\_6\_20141030\_00006.jpg

LM Start	0.11	Rating **	A	Issue No.	6
LM End	2.17	Issue Type +	Ma	Location *	LS
Category	Earthen Levee			GPS Latitude/Longitude	
				Start	End
Item	Vegetation			37.771475 °	37.751738 °
				-121.300343 °	-121.298302 °
DWR ID	DWR_RD2094_01_f_2014_6				
Action/Comments					
Control annual grass and weeds on the levee slopes and easements. Inspector Comments: Great job maintaining levee slopes.

View of the acceptable levee vegetation control.

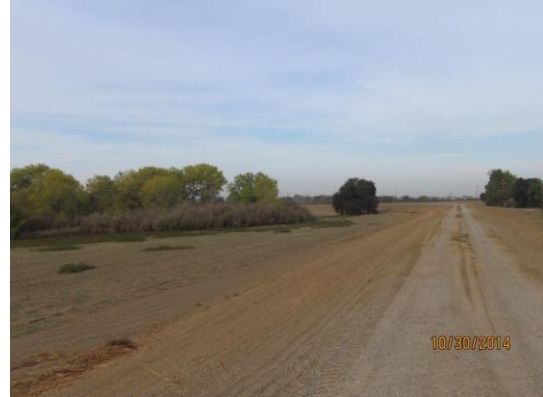
Photo 1 of 1 : FA\_2014\_RD2094\_321\_1\_20141030\_00001.jpg

LM Start	0.01	Rating **	A	Issue No.	1
LM End	0.45	Issue Type +	Ma	Location *	WS
Category	Earthen Levee			GPS Latitude/Longitude	
				Start	End
Item	Vegetation			37.759281 °	37.760599 °
				-121.299796 °	-121.307077 °
DWR ID	DWR_RD2094_02_f_2014_1				
Action/Comments					
Control annual grass and weeds on the levee slopes and easements.

View of the acceptable levee vegetation control.
